Manhole Inspection Summary

Manhole # S5100_002MH

Record Plat: **5100** Node: **002** Status: **Found**

Location Address: **Elmora**

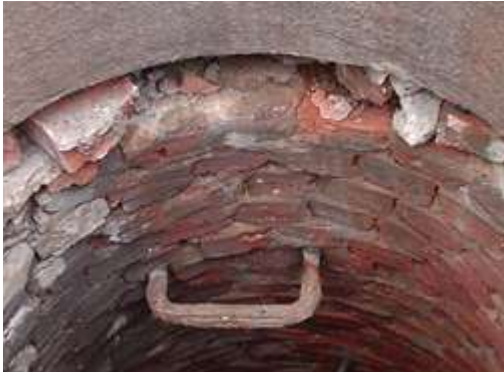
Defect 2

Chimney / Frame Adjustment ☒ Exists Material: **Brick** ☐ Parged Height: **3** (in.)
Condition: ☐ Sound ☐ Cracked ☐ Root Intrusion ☒ **Loose Brick** ☐ Deteriorated
Infiltration: ☐ None ☒ **Joint** ☐ Cracks ☒ **Mortar** ☐ Roots ☐ Wall

Loose bricks

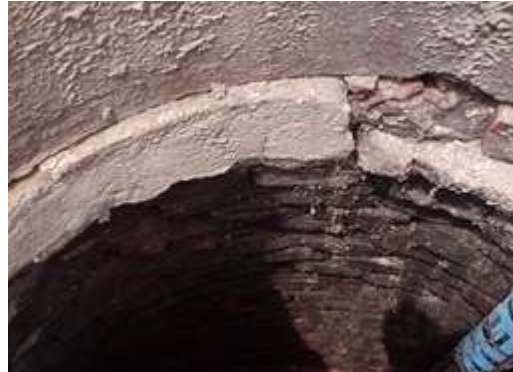
Defect 1

Frame Offset: **2** (in.) Condition: ☐ Sound ☐ Cracked ☒ **Leaks**

Frame leaks

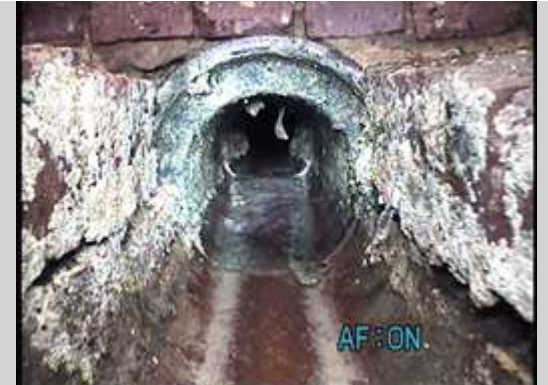
12 O'Clock Outflow

8 in. Circular Gravity Sewer
Pipe Out @ 12 O'Clock

Pipe Height: **8.4** (in.) Rod and Bar (Angled)
Pipe Material: **Clay** ☐ Pipe Lined
Invert Depth: **7.70** (ft.) Flow Characteristics: **Slow**
Deposits: ☒ None ☐ Mud ☐ Sludge ☐ Debris ☐ Grease
Silt Depth: (in.) Deposits Extent:
Infiltration: **None** Pipe Seal Cond: **Sound**

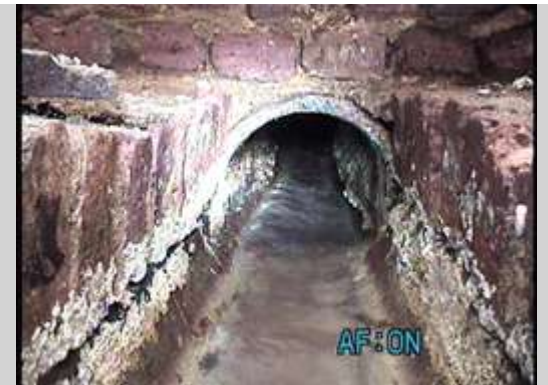
6 O'Clock Inflow

8 in. Circular Gravity Sewer
Pipe In @ 6 O'Clock

Pipe Height: **8.4** (in.) Rod and Bar (Angled)
Pipe Material: **Clay** ☐ Pipe Lined
Invert Depth: **7.65** (ft.) Flow Characteristics: **None**
Deposits: ☒ None ☐ Mud ☐ Sludge ☐ Debris ☐ Grease
Silt Depth: (in.) Deposits Extent:
Infiltration: **None** Pipe Seal Cond: **Sound**
